Wooden Artifacts Group Postprints

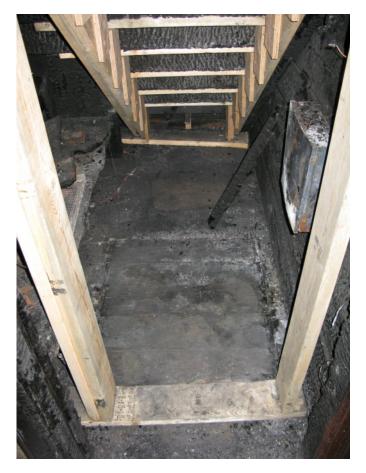
Fig. 2. The site of ignition under the central staircase of Craigflower Manor (Courtesy of Deborah Hudson)

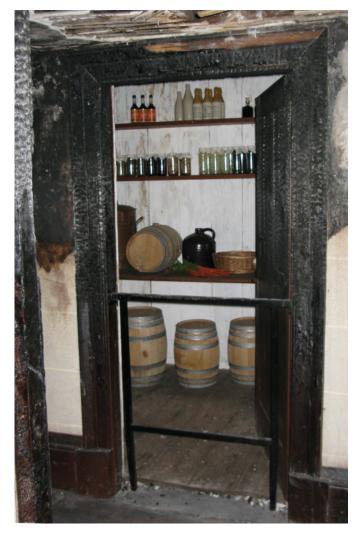
Fig. 3. Example of the extensive damage to millwork caused by the fire (Courtesy of Deborah Hudson)

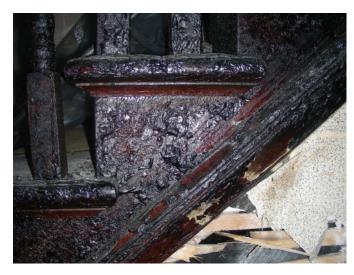
Fig. 4. Example of the charred and blistered finish on the staircase caused by the fire (© Government of Canada, Canadian Conservation Institute. CCI 100841-0029)

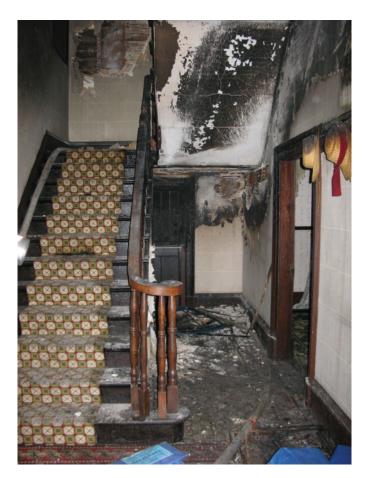
Fig. 5. The central hall and staircase of Craigflower Manor after the fire (Courtesy of Deborah Hudson)

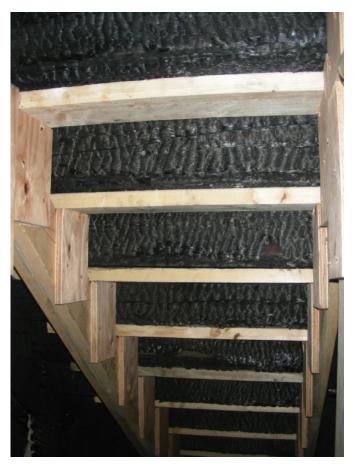
Fig. 6. The auxiliary support installed to support the damaged staircase (© Government of Canada, Canadian Conservation Institute. CCI 100841-0025)

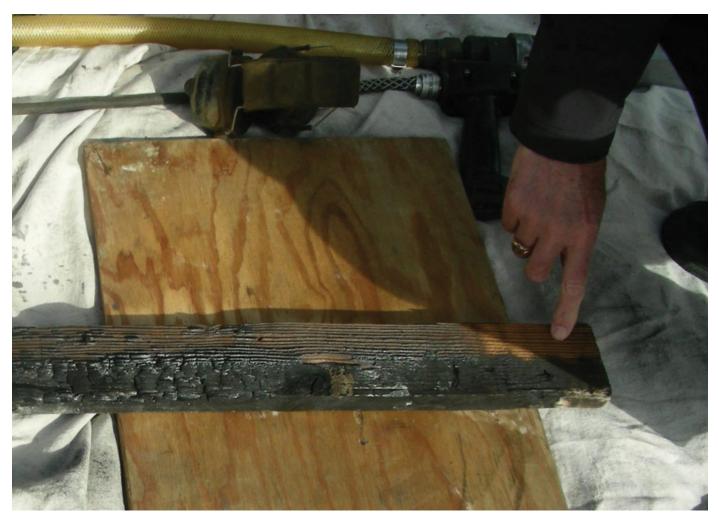
Fig. 7. Testing on a charred wood member removed from the Manor demonstrating the effect of the dry ice blasting (© Government of Canada, Canadian Conservation Institute. CCI 100841-0040)

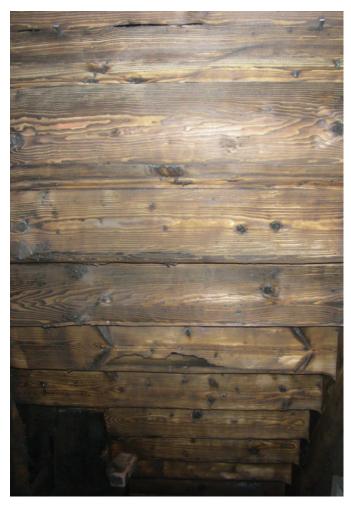
Fig. 8. Staircase substructure after dry ice blasting treatment (© Government of Canada, Canadian Conservation Institute. CCI 100841-0053)

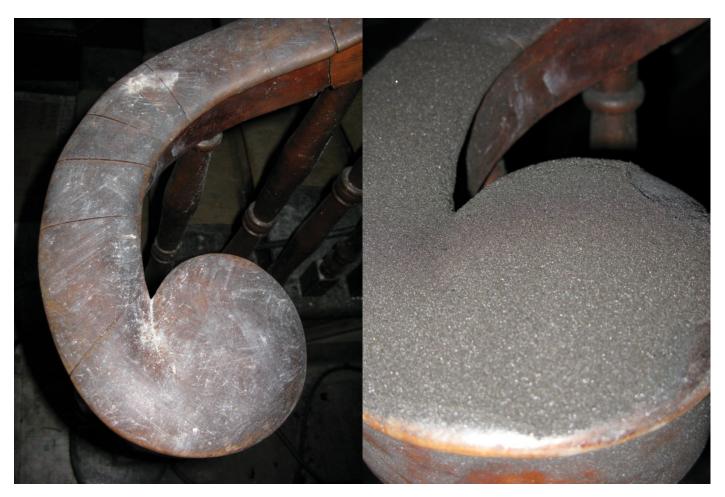
Fig. 9. The staircase handrail after the fire (a) and after contamination of primary waste from the dry ice blasting treatment (b) (Courtesy of Deborah Hudson)

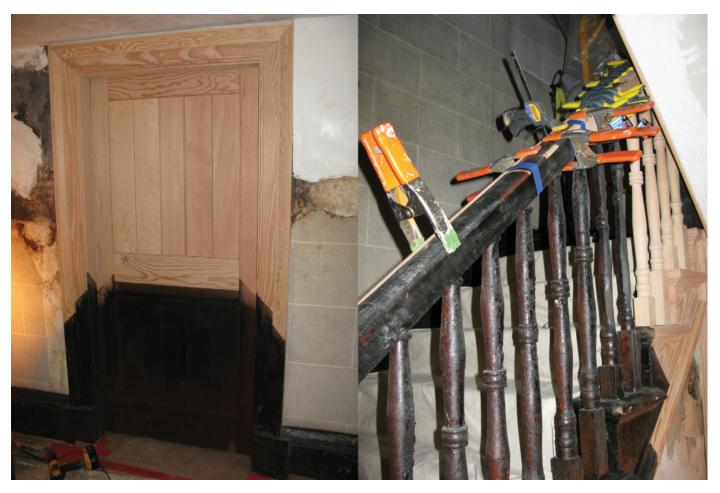
Fig. 10. Replacement millwork surrounding the entrance to the larder (a) and replacement spindles and handrail components installed in the balustrade before finishing (b) (Courtesy of Deborah Hudson)

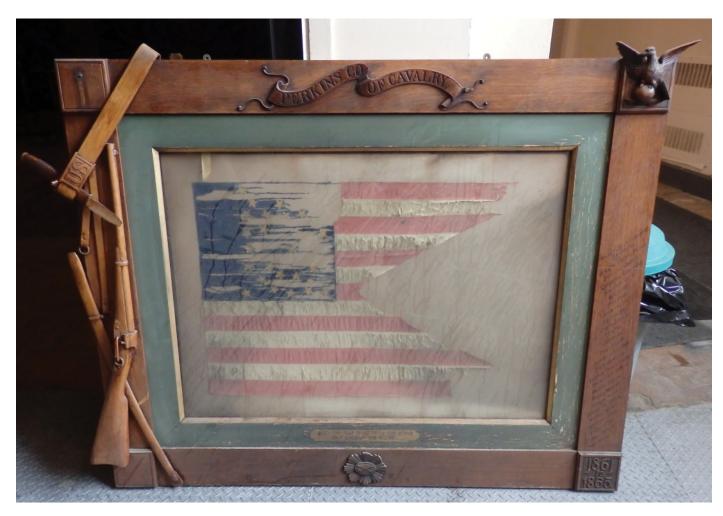
Fig. 1. Flag and frame as found in the basement of the Lowell Memorial Auditorium, 2014 (Courtesy of Richard Howe)

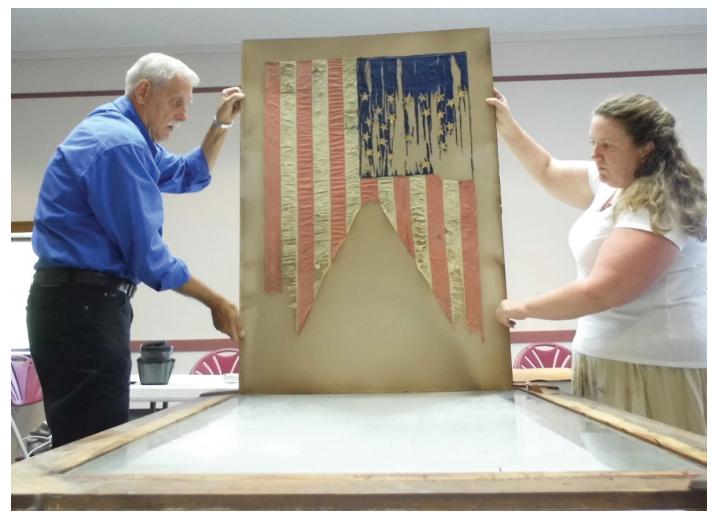
Fig. 3. Bob Marshall and Camille Myers Breeze removing the Perkins flag from the frame

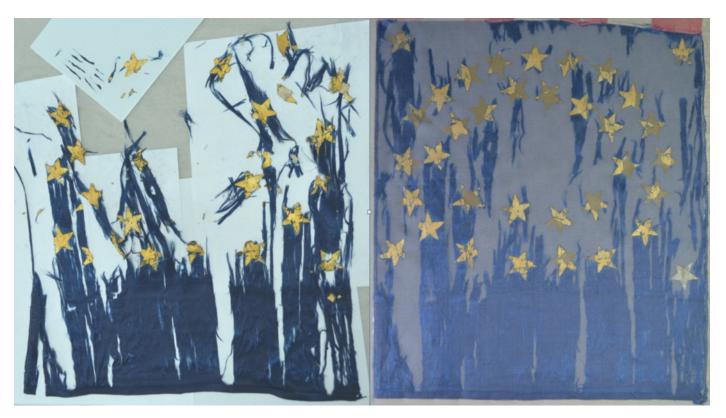
Fig. 4. Comparison of the canton after removal from the cardboard (left) and after stabilization with star dummies (right).

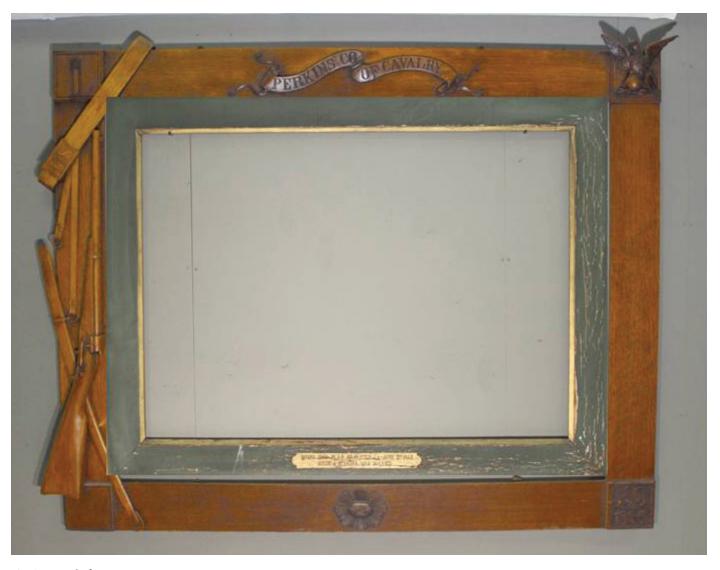
Fig. 6. Frame before treatment

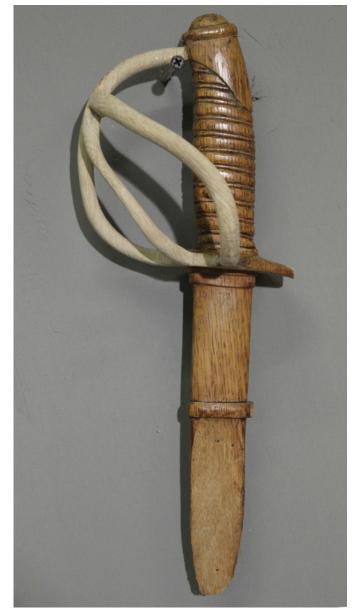
Fig. 8. Saber carving with replacements

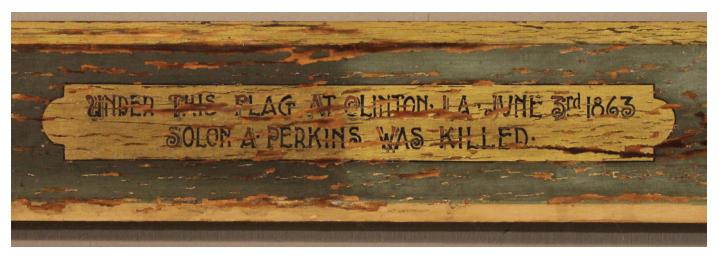
Fig. 9. Inner frame inscription during cleaning

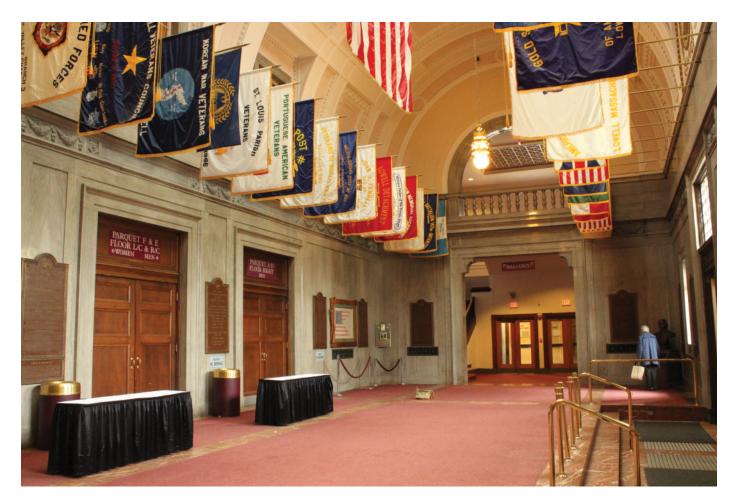
Fig. 10. Lowell Memorial Auditorium Hall of Flags, 2015

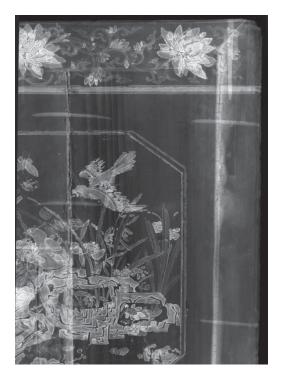
No tenons were found in the RMA screen, as both the bottom rail and the mitered top rail are joined to the vertical planks using only bamboo dowels. The additional pierced and gilded aprons placed below the bottom rails are inserted into a tongue and groove running along the sides and top edge, identical to the red painted rail on the MMA screen. However, and very different from the MMA screen, as reinforcement, two crossrails were inserted into thin channels cut into the upper and lower half of each panel (fig. 3). Since the lacquer panels of the RMA's Leeuwarden Room were reduced in height, thinned down to about 7-mm-thick sheets and then cradled from the back, it was not possible to determine their complete array of

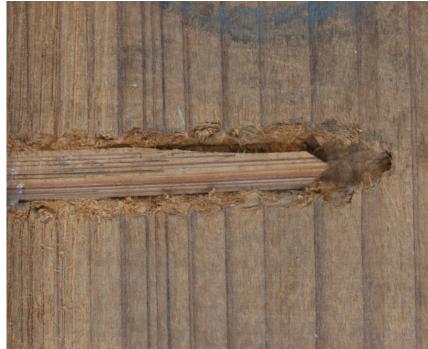
Fig. 2. Left: Screen (09.6a-l), detail of a digitally enhanced x-ray radiograph showing dowels are used to join the top rail and vertical planks. Right: Leeuwarden Room (BK-16709), detail with the remaining half of a bisected dowel on the back of one of the split panels.

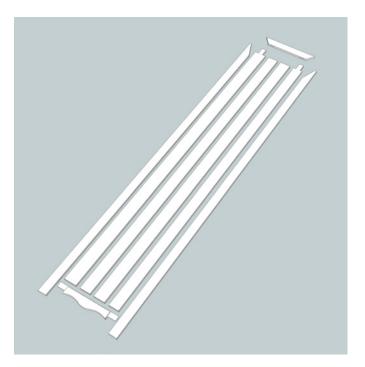
Christina Hagelskamp 29

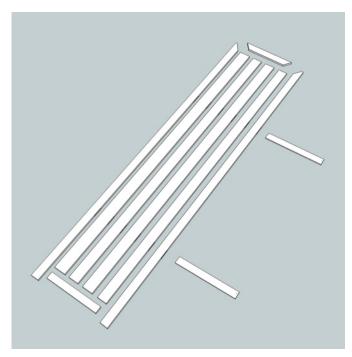
Fig. 3. Construction sketches illustrating the two styles of joinery found on the three objects. All three also incorporate dowels to join the individual members. Left: The system of mortise-and-tenon joints on screen (09.6a-l). Right: A pair of inserted cross-rails found on both Rijksmuseum objects.

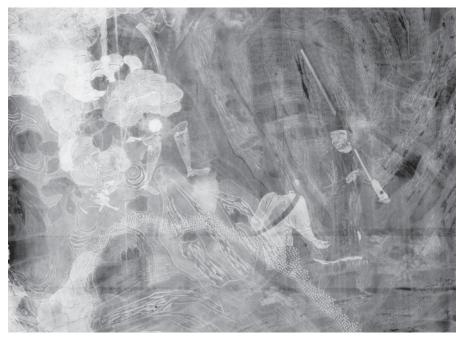
A related method of stabilizing panels was found on several other screens, among which is an example from the Philadelphia

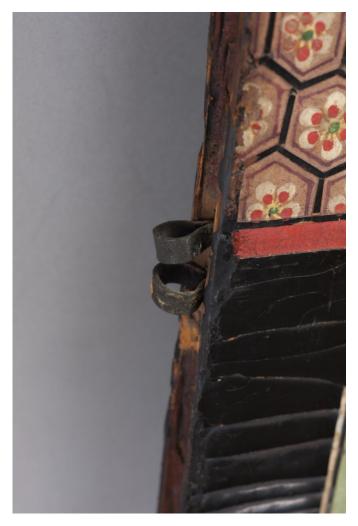
Fig. 5. Screen (09.6a-l), details of original pin-and-loop hinging mechanism.

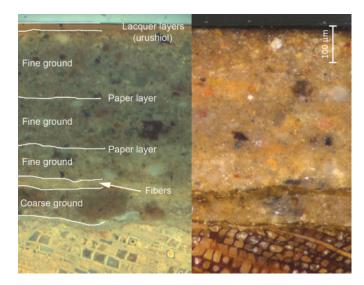
The unique opportunity of comparing corresponding panels from the three closely related screens incorporated in the Leeuwarden room revealed interesting details regarding the possible use of paper transfers. The primary layout of the palace

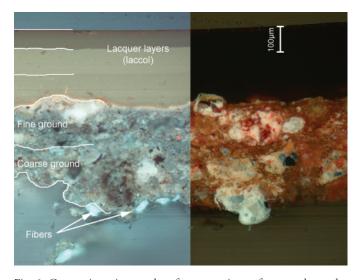
Fig. 6. Composite micrographs of cross sections of prepared samples from BK-16709 (top), BK-1959-99 (center), 09.6a-l (bottom), under visible and ultra-violet light.

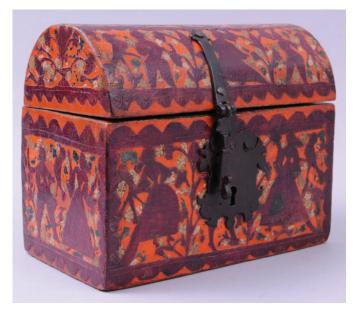
Fig. 5. Coffer, Olinalá, Mexico, ca. 1800. Wood with Mexican lacquer, metal hardware. $19.5 \times 23.5 \times 13.5$ cm. Hispanic Society of America, New York. LS2249.

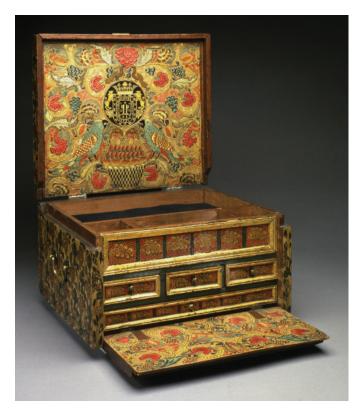
Fig. 6. Portable writing desk, Pasto, Colombia, ca. 1684. Wood with barniz de Pasto, yellow metal hardware. 20 × 31 × 36 cm. Hispanic Society of America, New York. LS2000.

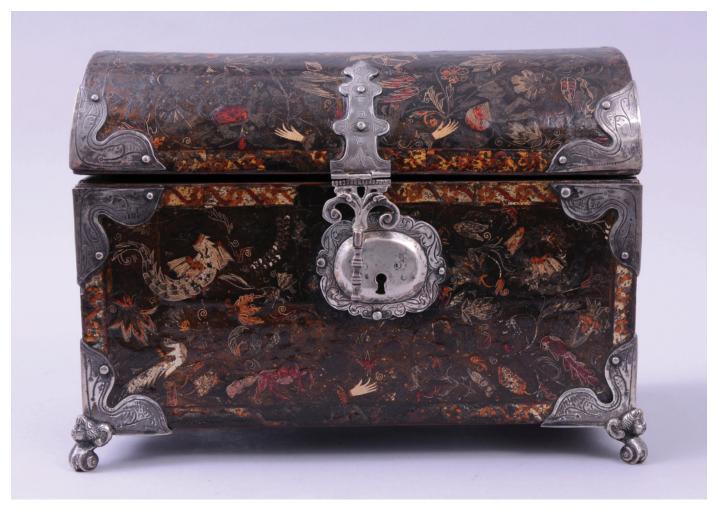
Fig. 8. Coffer, Pasto, Colombia, ca. 1650. Wood with barniz de Pasto, silver hardware. 19.2 × 27.2 × 13.6 cm. Hispanic Society of America, New York. LS2067.

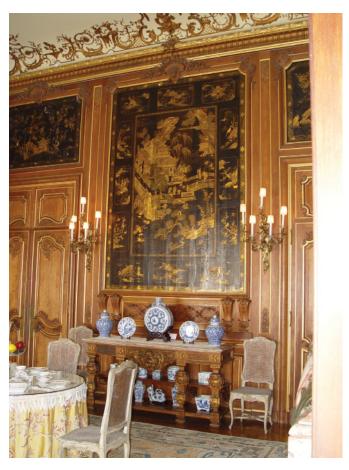
Fig. 2. Lacquer panel and overdoors in the Breakfast Room

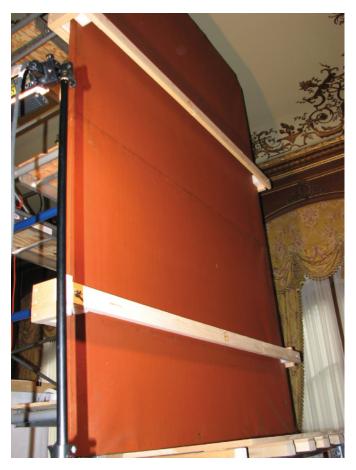
Fig. 3. The rear of the panel is covered with thick paper.

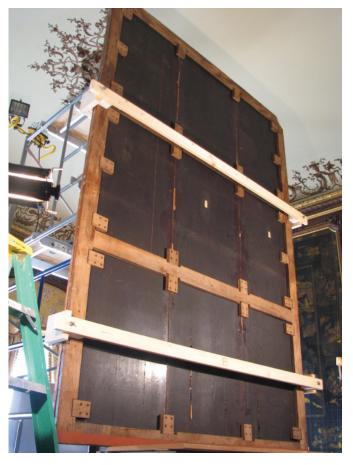
Fig. 4. Underneath the paper is a cradle supporting three lacquer panels glued together. The lacquer on the back is uncolored, and there is no decoration.

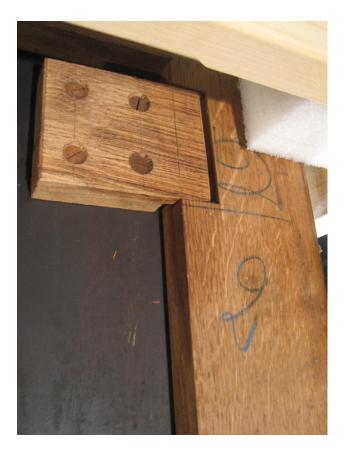
Fig. 5. Slip joint with French witness marks on the cradle

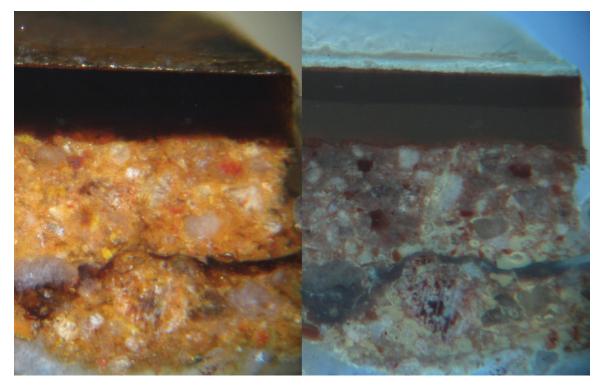
Fig. 11. This cross section image from an antique panel is typical of 18th-century Chinese export lacquer

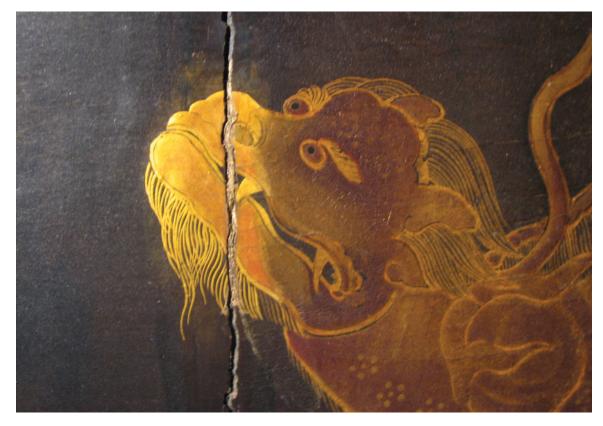
Fig. 12. Example of very high quality repairs that were made to the panels

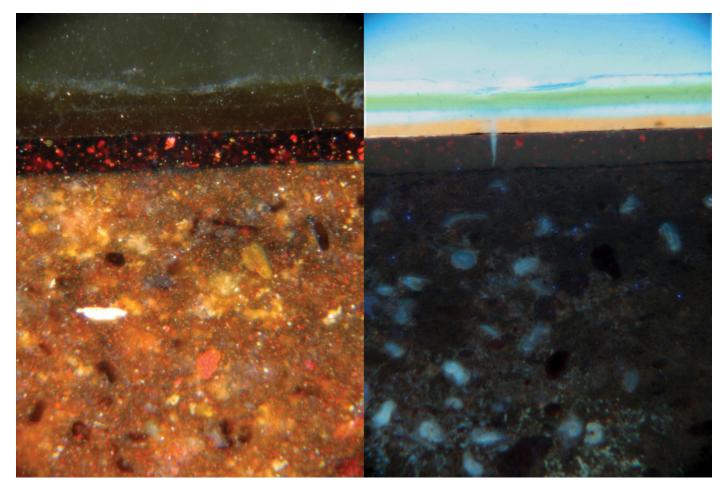
Fig. 13. Cross section of the Fine Repair material. Note embedded fibers, pigmented lacquer, and use of shellac.

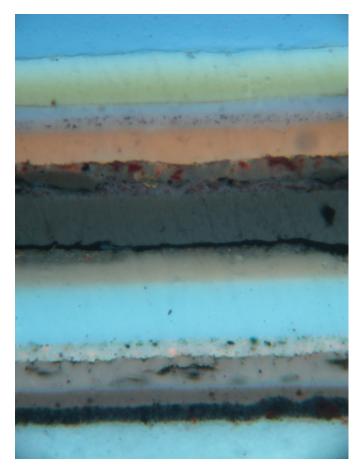
Fig. 14. The Asian lacquer has been applied on top of an earlier repair using European methods.

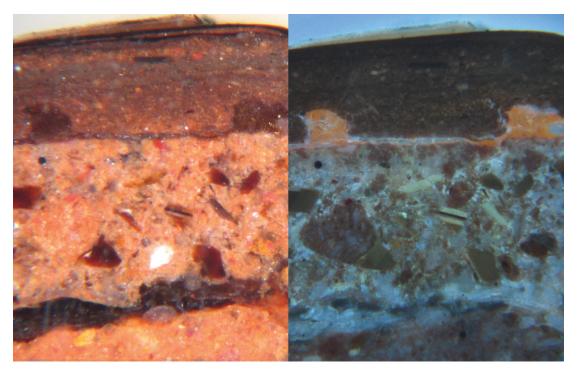
Fig. 15. The lacquer on the West panel has a pigmented finish layer and embedded fibers. Fragments of lacquer, complete with stratigraphy, are found as filler in the ground layer.

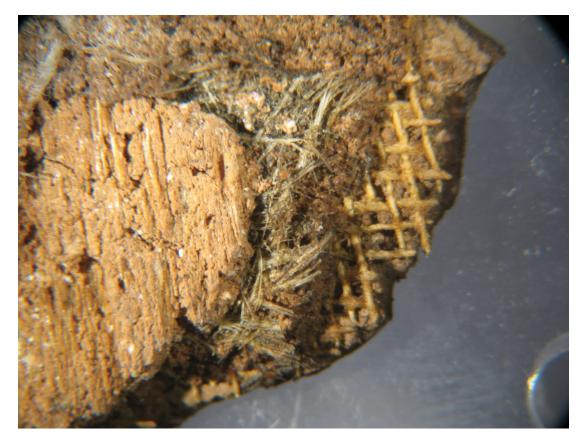
Fig. 16. A non-woven mat and a coarsely woven textile are embedded in the layers of the lacquer used on the West panel.

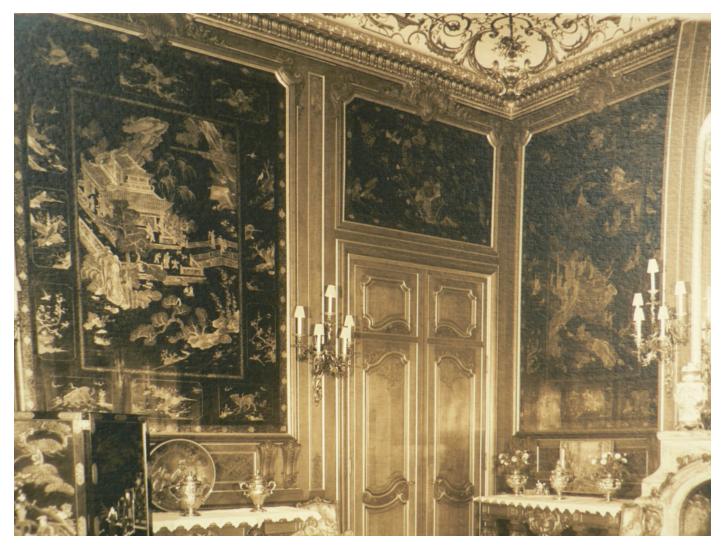
Fig. 18. Vintage photo of the Breakfast Room in 1901

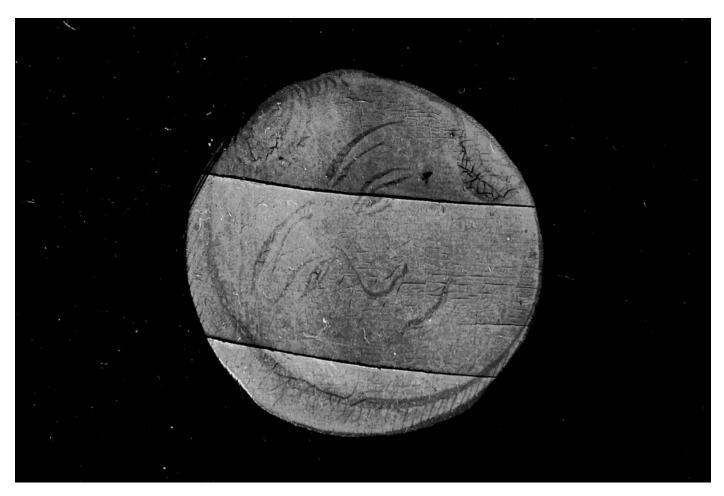
Fig. 25. The Man in the Moon, desaturated and enhanced for clarity in Adobe Photoshop

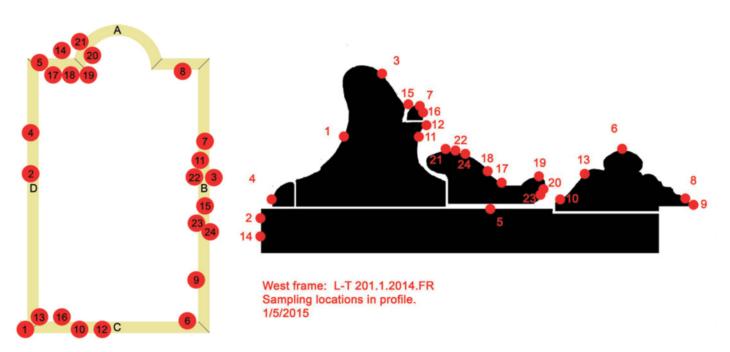
Fig. 4. Overview of sample locations, maps in plan, and elevation.

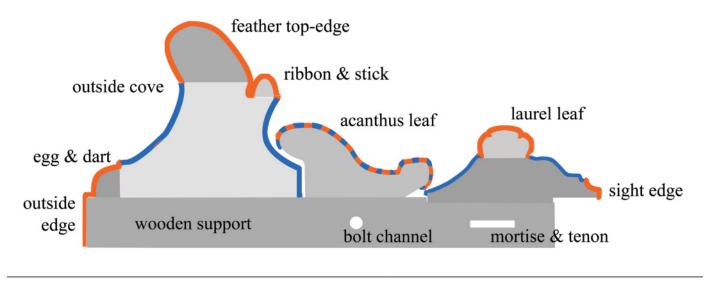
Water Gilt.Oil Gilt.Repeating pattern of both water and oil gilding.

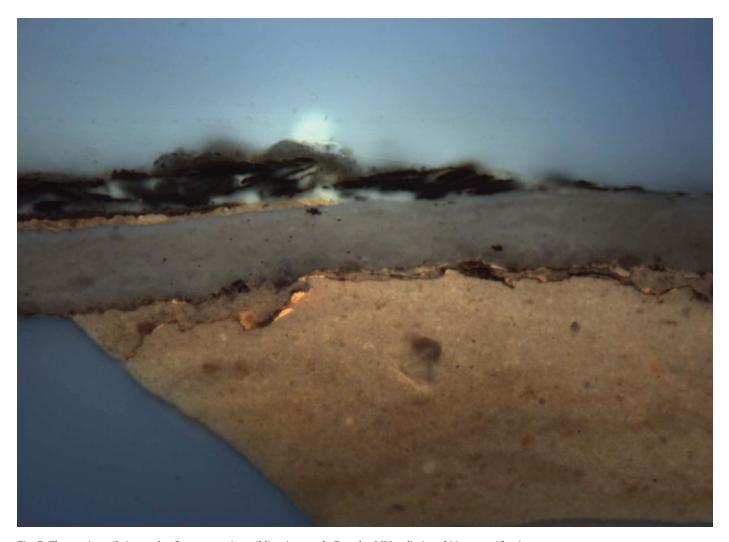
$Fig.\ 7.\ Fluorescing\ oil\ size\ under\ first-generation\ gilding\ in\ sample\ 7\ under\ UV\ radiation, 200x\ magnification$

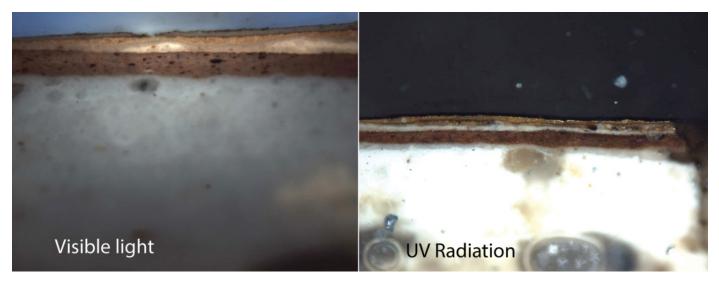
Fig. 8. Sample 1 in visible light 100x, and UV radiation 200x, example of first-generation water gilding at the back cove

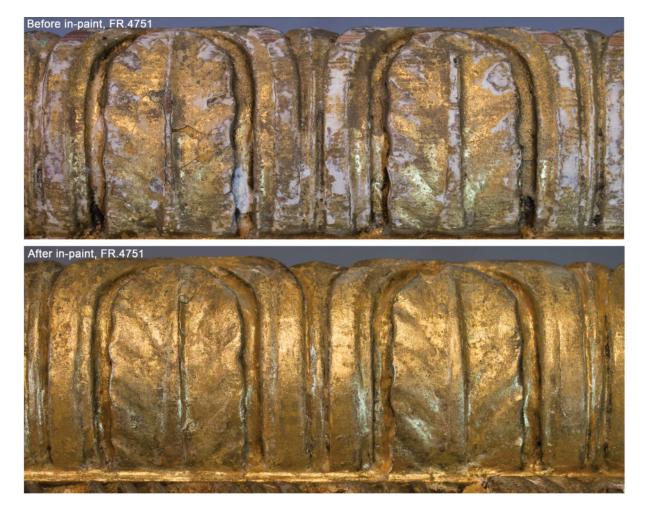
Fig. 10. Section showing the frame before and after in-painting.

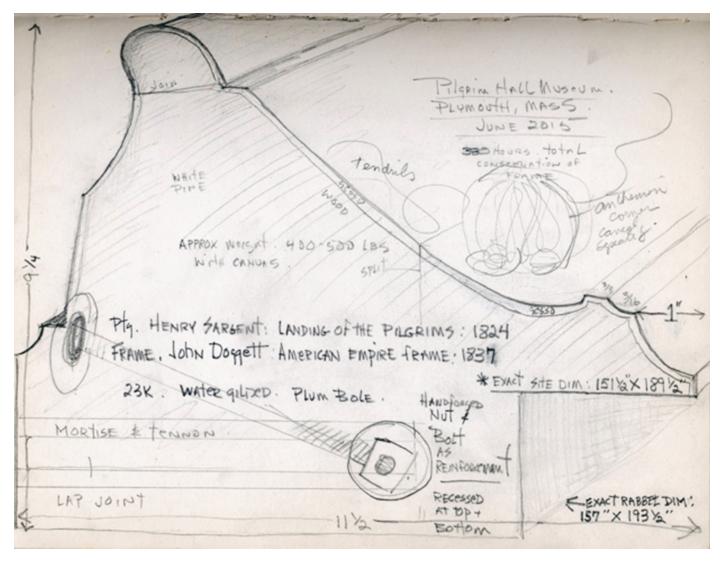
Fig. 1. Profile drawing by William B. Adair for the 19th-century American Empire frame made by John Doggett

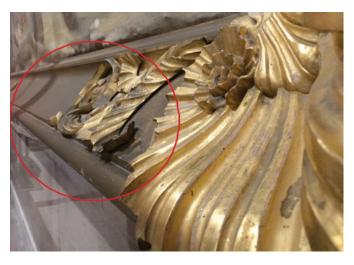
Fig. 2. Intermittent sections of the frame were covered with bronze paint. The paint covering the entire length of the bottom rail and lower sections of the sides had oxidized over time.

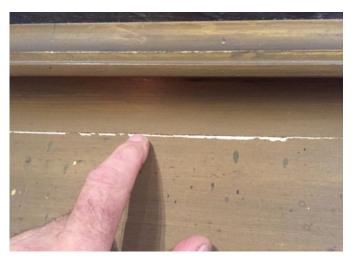
Fig. 3. The joint line along the two large frame members was failing and especially visible along the bottom rail.

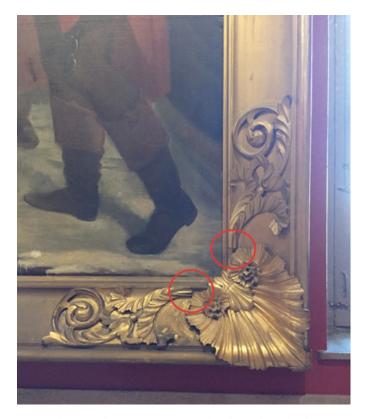
Fig. 4. The tendril ornamentation, attached by nails to the frame, did not line up properly with the cartouches at all four corners.

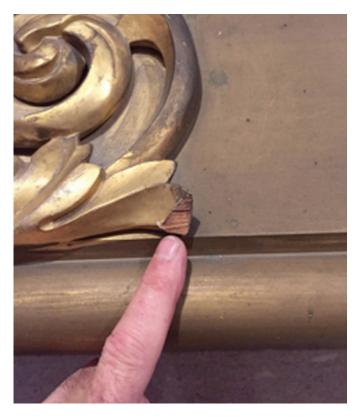
Fig. 5. Example of ornament loss found throughout the frame.

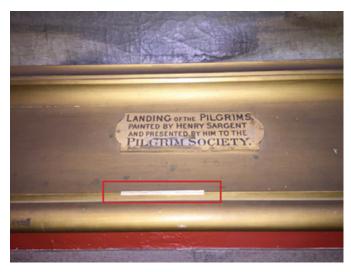
Fig. 6. Example of intermittent gesso loss found throughout the frame

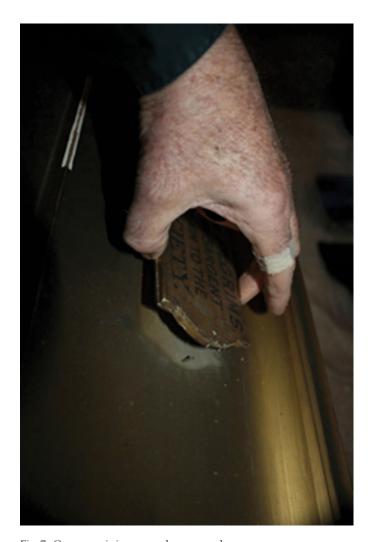
Fig. 7. Current existing nameplate removal.

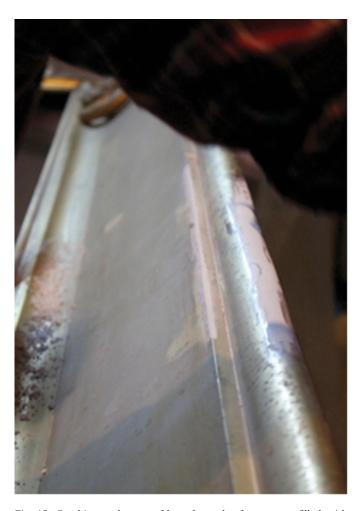
Fig. 15. Cracking and areas of loss along the frame were filled with putty and sanded down to match the existing contours of the frame.

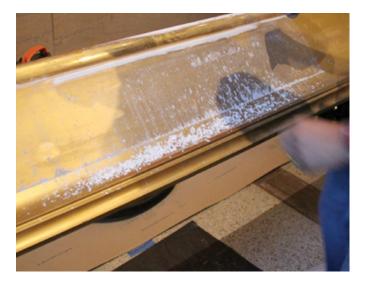
Fig. 14. Cracking and areas of loss along the frame were filled with putty and sanded down to match the existing contours of the frame.

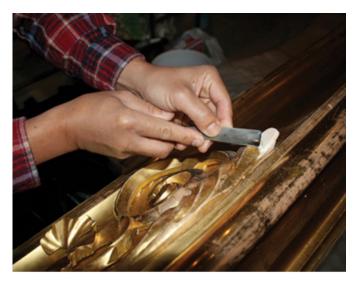
Fig. 16. Areas of missing ornament are filled with basswood

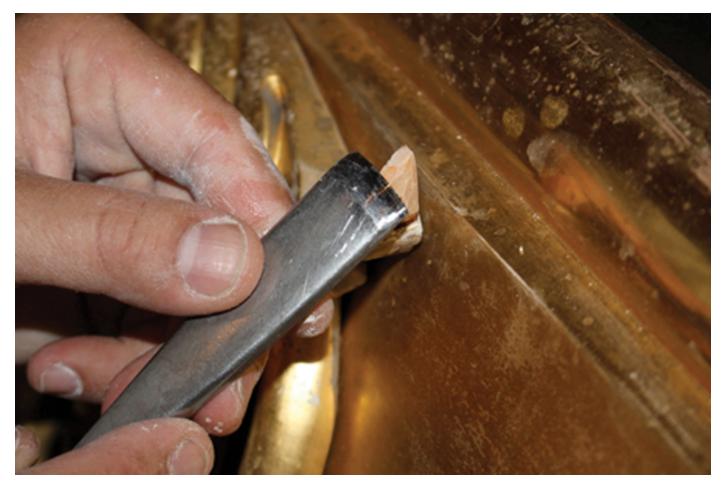
Fig. 17. The newly attached basswood was hand carved to match the existing contours of the ornamentation.

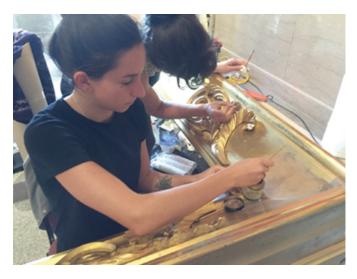
Fig. 23. The Gold Leaf Studios conservation team filling small cracks and minor gesso losses with gold pigments

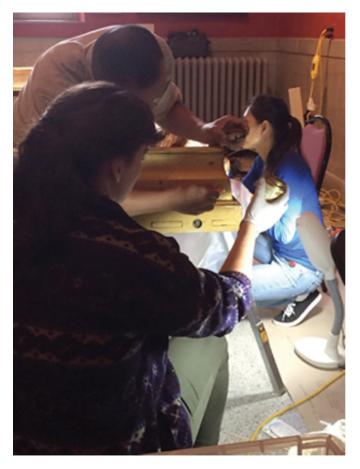
Fig. 24. The Gold Leaf Studios conservation team filling small cracks and minor gesso losses with gold pigments

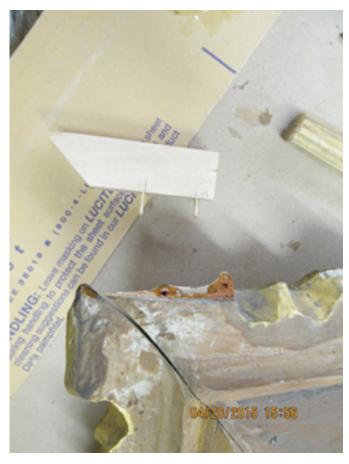
Fig. 25. A piece of basswood prepared to be affixed to an area of ornament loss using rods and PVA glue.

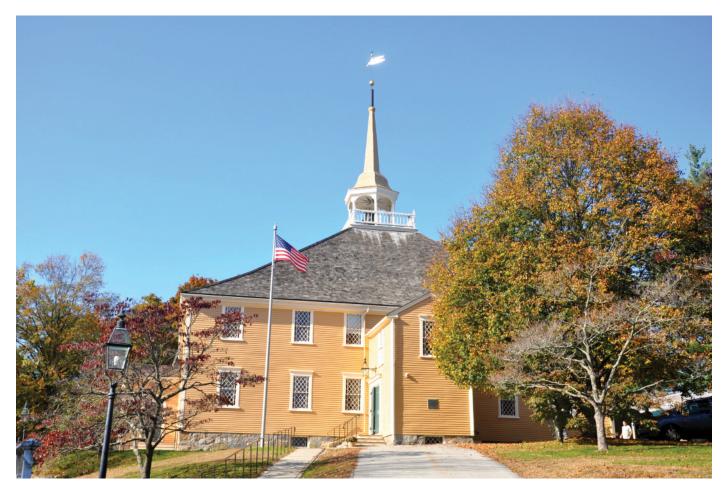
Fig. 1. Exterior view of Old Ship Church, south façade, 2014 (Courtesy of Building Conservation Associates Incorporated)

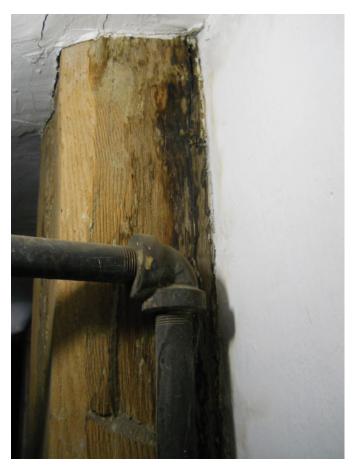
Fig. 2. Dark-colored staining on historic oak post, pew 38 area, 2015 (Courtesy of the author)

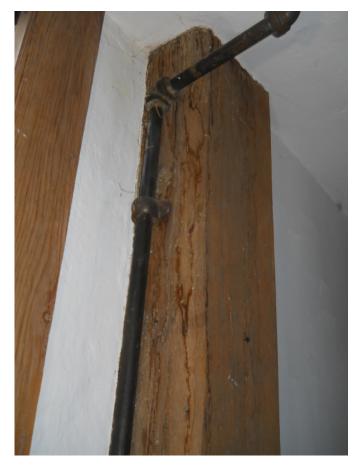
Fig. 3. Ferrous metal sprinkler pipe and head (ca. 1930), contributing to adjacent wood waterborne staining, 2015 (Courtesy of the author)

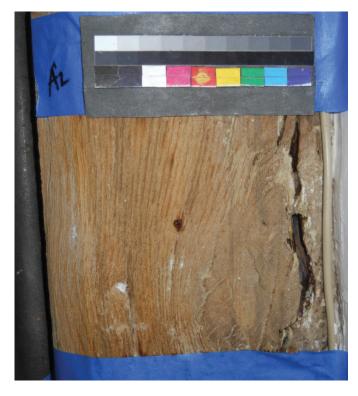
Fig. 4. (a) Post in pew 41 test area shown before dual-chelator cleaner application, 2015. (b) Post in pew 41 test area shown after dual-chelator cleaner application and clearance, 2015. (Courtesy of the author)

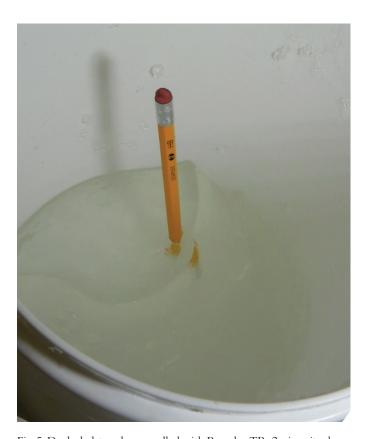
Fig. 5. Dual-chelator cleaner gelled with Pemulen TR-2, viscosity demonstrated by full vertical support of a number two pencil (Courtesy of the author)

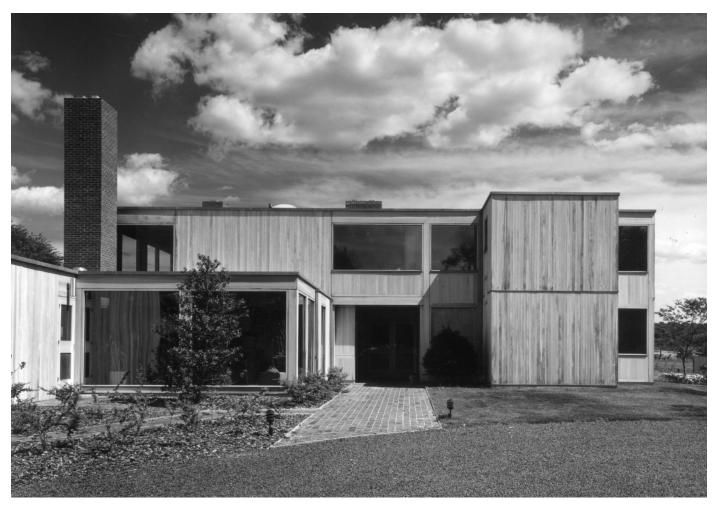
Fig. 4. Korman House, Whitemarsh Township, PA (1971–1973), photographed by Jamie Ardiles-Arce, ca. 1974 (Courtesy of the Kahn Collection)

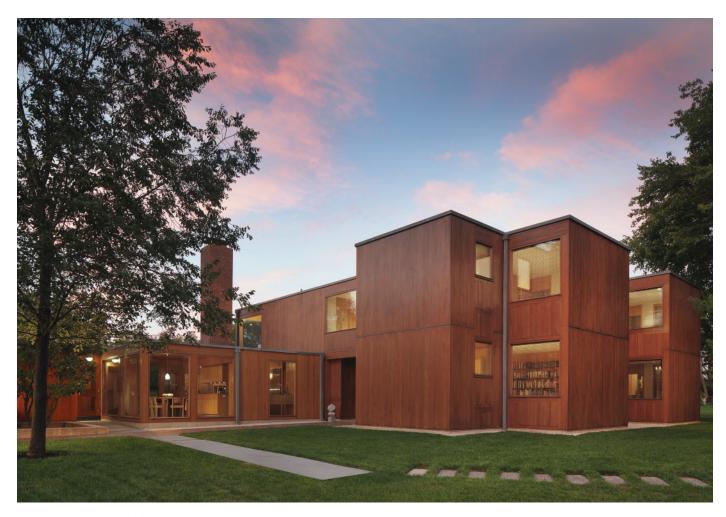
Fig. 5. Korman House, before treatment, 2014

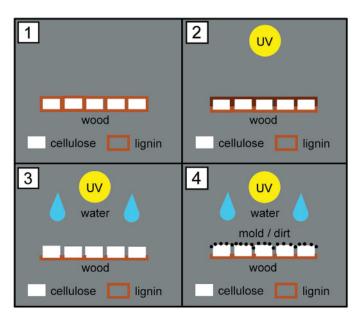
Fig. 6. Chromatic illustration of lignin degradation

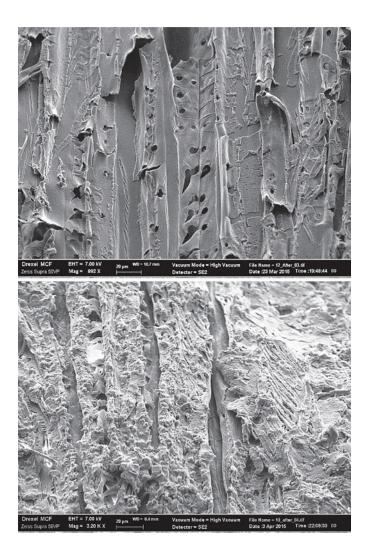
Fig. 7. SEM imaging of Korman House cypress untreated (top) and treated after 800 hours of QUV-B (bottom)

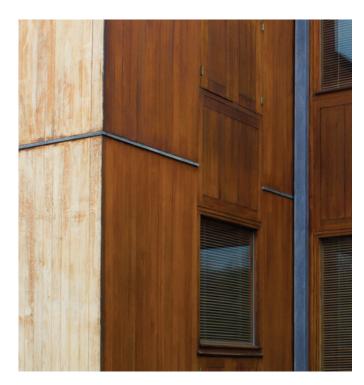
Fig. 8. During treatment, removal of existing finish (left area)

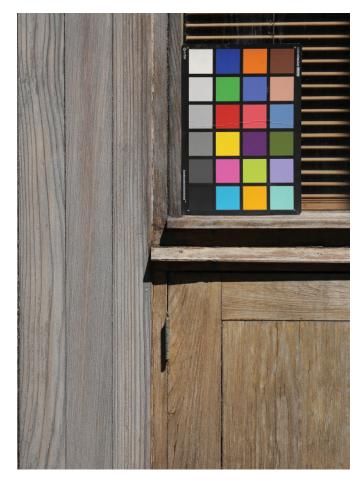
Fig. 9. Application of TWP (left area treated)
